Building eValuate

Residential Pre-purchase Inspection Report

Date of inspection: Wednesday, 08 July 2009 12:00 AM

Property address	288 Lacie Street SOUTH HOBART TAS 7004
Report prepared for	Simon Smith & Sue Citizen 1098 Mount Road NORTH HOBART TAS 7000
Client's contact details	Mobile 0491 312 559 Home (03) 6212 3498 Work (03) 6212 3498 mrcitizen@bigplace.net.au
Real estate agent's details	Name Scott and Associates Company Robert Scott Mobile 0458 987 365 robert@scassoc.net.au
Type of inspection report	Standard Inspection, Defect Only
Inspector	Paul Kleywegt , Accredited Bulider, HIA Member Licence CC 4045 J

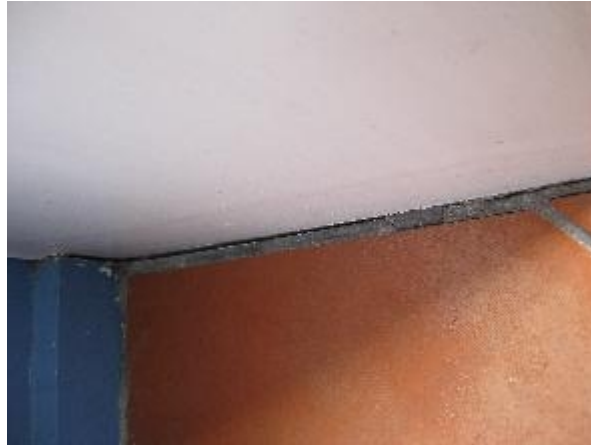
Tiles Grouting and sealant Minor Defect Type: F

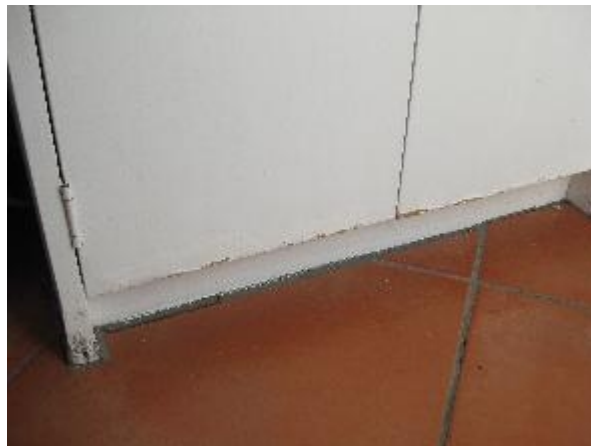
Tiles Sealant missing Minor Defect Type: F
Missing grout or sealant can allow water to penetrate into subfloor space or wall cavities, possibly resulting in structural breakdown and/or mould issues. Recommend sealing with flexible sealant.

Vanity cupboard Water damage Minor Defect Type: C
Bulging timber and peeling paint at base of vanity unit indicates water damage.

Missing grout or sealant can allow water to penetrate into subfloor space or wall cavities, possibly resulting in structural breakdown and/or mould issues. Recommend sealing with flexible sealant.

Bulging timber and peeling paint at base of vanity unit indicates water damage.

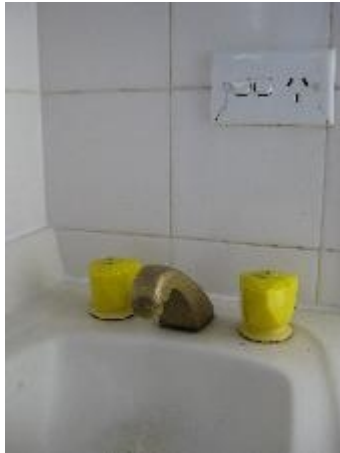
Power points Cracked Safety Hazard Type: A
Power point above hand basin is cracked and positioned too close to basin to comply with current electrical standards. Recommend removal and resiting by a licensed Electrician.

Power point above hand basin is cracked and positioned too close to basin to comply with current electrical standards. Recommend removal and resiting by a licensed Electrician.

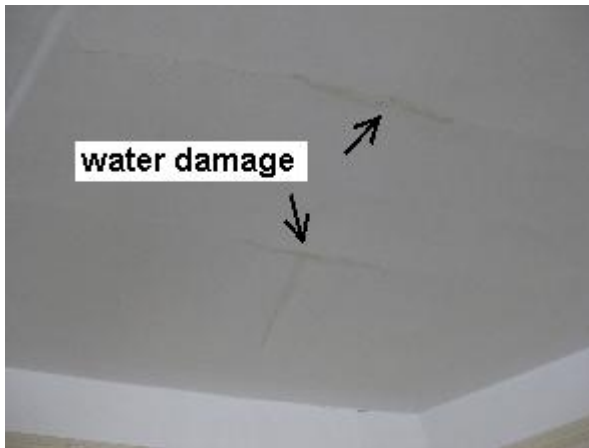
Ceilings & cornices Leakage evidence Further Investigation Type: D
Water damage is evident by discolouration and bulging of plaster along crackline. Moisture meter readings indicate normal moisture levels present. This is possibly due to a past chimney flashing issue which has been rectified. It would appear that a new flashing has been installed on the roof above this area.

Water damage is evident by discolouration and bulging of plaster along crackline. Moisture meter readings indicate normal moisture levels present. This is possibly due to a past chimney flashing issue which has been rectified. It would appear that a new flashing has been installed on the roof above this area.

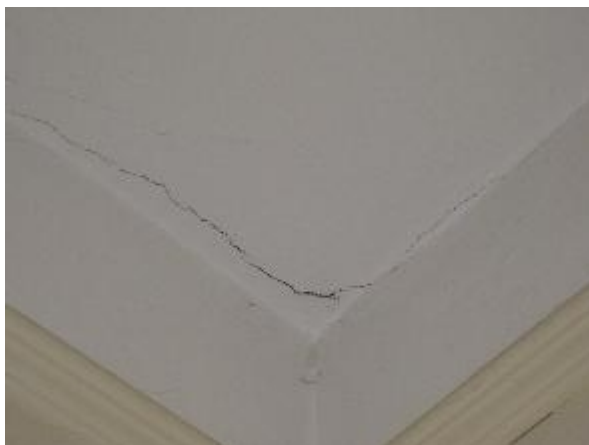
Ceilings & cornices Splitting ceiling at joint Minor Defect Type: A

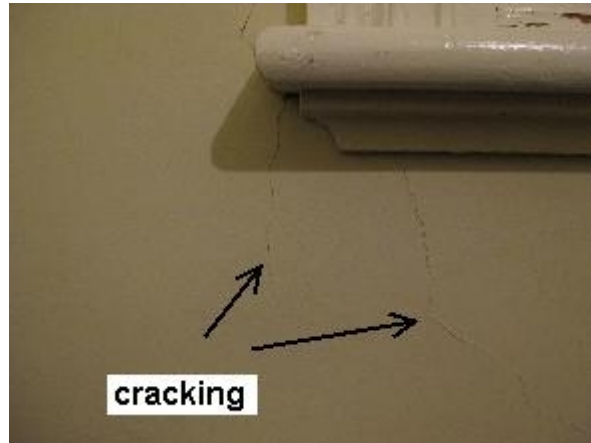
Windows Sash fittings and hardware Minor Defect Type: A
Sash cord is broken on right hand window. Window is painted shut and unuseable.

Walls Drummy plaster and render Further Investigation Type: C
Plaster render below window is drummy and cracked suggestive of water penetration. Moisture levels measured were higher than normal. The client also had concerns regarding a musty smell in the room. This wall area corresponds to the front exterior wall where there is evidence of salt damp (see Exterior-front elevation notes). Further investigation by a Damp Specialist is recommended.

Plaster render below window is drummy and cracked suggestive of water penetration. Moisture levels measured were higher than normal. The client also had concerns regarding a musty smell in the room. This wall area corresponds to the front exterior wall where there is evidence of salt damp (see Exterior-front elevation notes). Further investigation by a Damp Specialist is recommended.

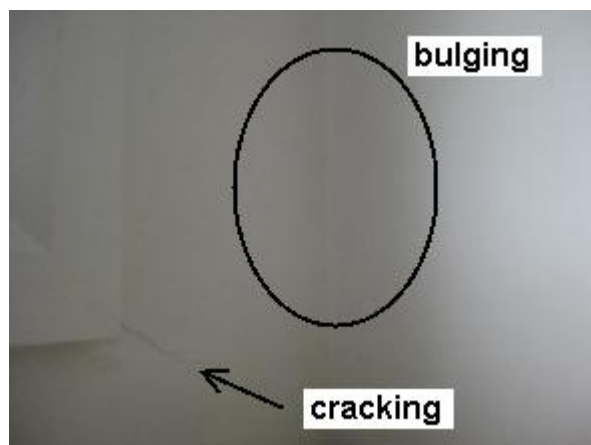
Walls Dampness and damp damage Further Investigation Type: C
Bulging in plaster sheet indicates water penetration behind sheet. Moisture meter reading is high in this area. Adjacent cracking would indicate slight movement at this point. The missing spreader downpipe referred to in "Roof-Exterior" could be the cause of the water penetration. Recommend further investigation by roof Plumber and/or Damp Specialist

Bulging in plaster sheet indicates water penetration behind sheet. Moisture meter reading is high in this area. Adjacent cracking would indicate slight movement at this point. The missing spreader downpipe referred to in "Roof Exterior" could be the cause of the water penetration. Recommend further investigation by roof Plumber and/or Damp Specialist

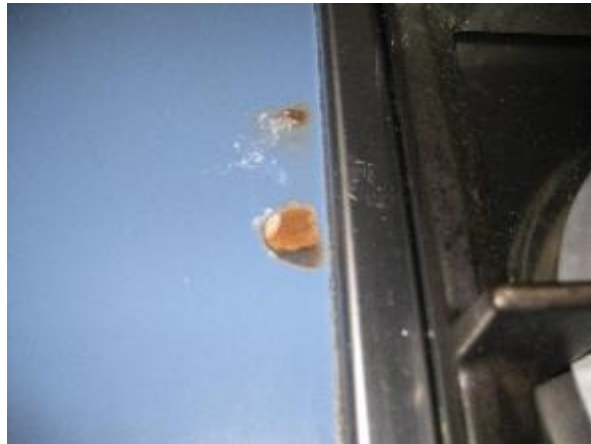
Taps Leakage at tap Minor Defect Type: E
Sink tap is leaking at mixer base. Recommend attention by Plumber.

Bench top Damage Minor Defect Type: A
Laminate bench top adjacent to gas cooktop has been burnt through surface.

Laminate bench top adjacent to gas cooktop has been burnt through surface.

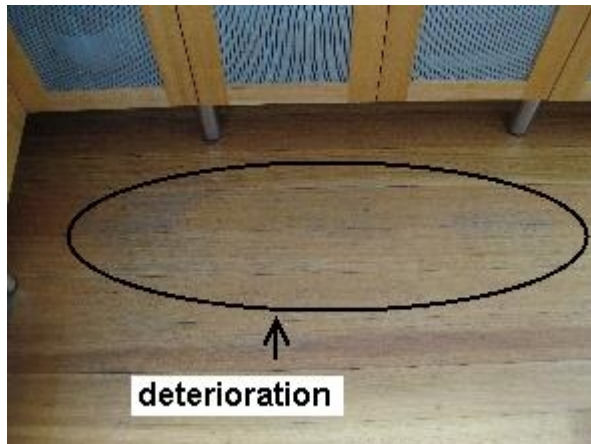
Floors Surface damage Minor Defect Type: A
Floor finish deterioration in heavy use areas. May allow some water penetration from splashing/spillage at sink. Recommend resealing floor.

Floor finish deterioration in heavy use areas. May allow some water penetration from splashing/spillage at sink. Recommend resealing floor.

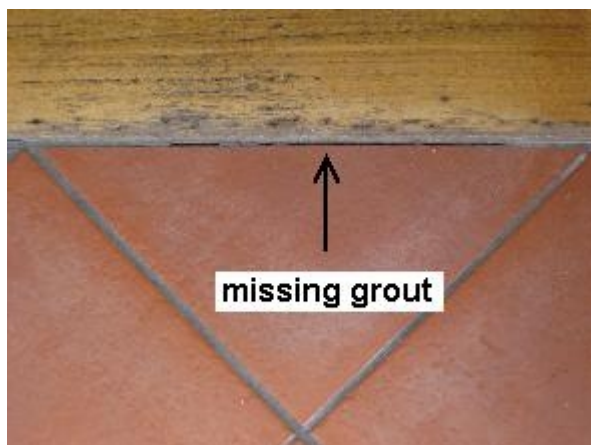
Tiles Sealant missing Minor Defect Type: A
Missing grout or sealant can allow water to penetrate sub-floor or wall cavities in wet areas, possibly resulting in structural breakdown and/or mould issues. Where tiles meet walls or fixed structures, a flexible sealant such as silicon should be used. Recommend replacing sealant as such.

Missing grout or sealant can allow water to penetrate sub-floor or wall cavities in wet areas, possibly resulting in structural breakdown and/or mould issues. Where tiles meet walls or fixed structures, a flexible sealant such as silicon should be used. Recommend replacing sealant as such.

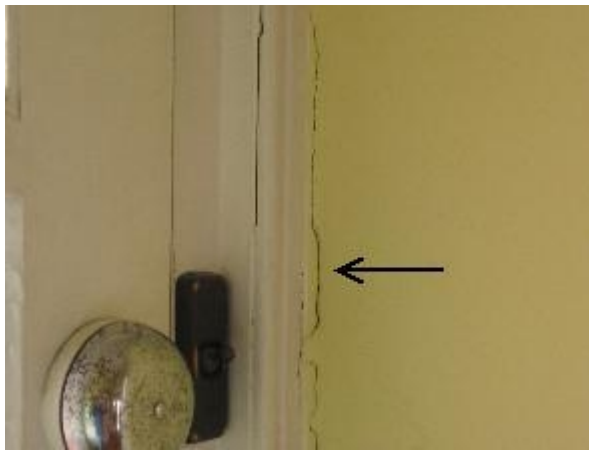
Walls Cracking Minor Defect Type: B

Wall cracking to right hand side of front door frame. This appears to be related to excessive movement in the door frame when door closes. Recommend additional fixing of door frame to wall by Builder.

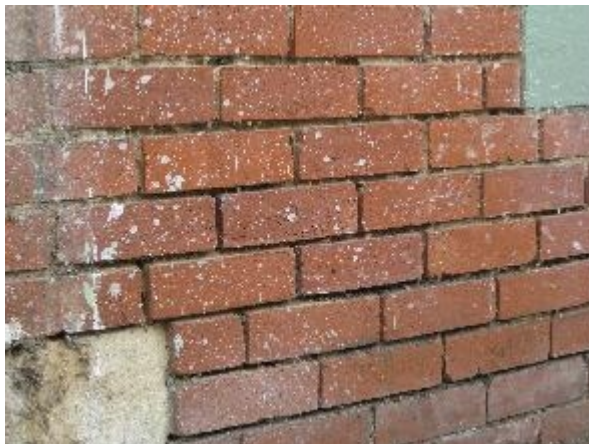
Walling Damp - rising Further Investigation Type: C

Missing mortar and white deposits on lower courses of brickwork indicates the presence of salt damp. Salt damp, also known as rising damp, is caused by the rise of saline water into the base or the lower sections of walls by capillary action. Comparative moisture meter readings indicated higher than normal moisture levels present. Further advice should be sought from a Damp Specialist and possible rectification methods investigated.

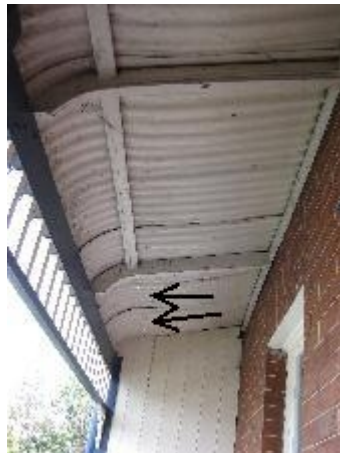
Patio/veranda Roof batten missing Safety Hazard Type: F

Veranda roof batten is missing. This reduces the structural support of roof sheeting and could be a safety issue in high winds or when roof is accessed. Recommend repair by a Builder.

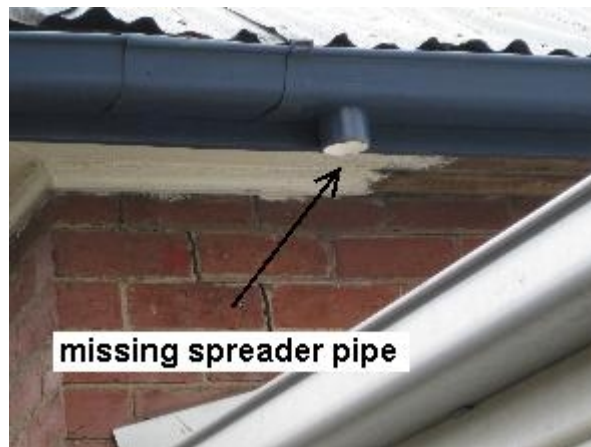
Down pipe missing

Spreader pipe which disperses water from upper roof gutter to lower roof is missing. This could lead to water penetration behind the kitchen extension wall flashings in windy conditions. This could be contributing to the bulging water damaged plaster evident in the kitchen below (see Interior-Kitchen).

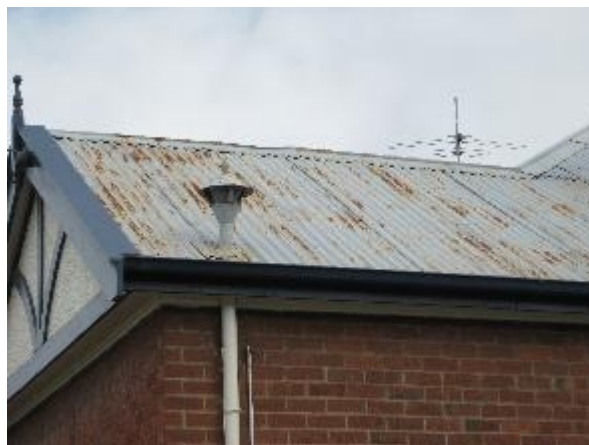
Roof iron corroded - surface

Surface corrosion present on roof sheeting. More prominent on northern face. Recommend repainting to preserve surface and prevent further deterioration.

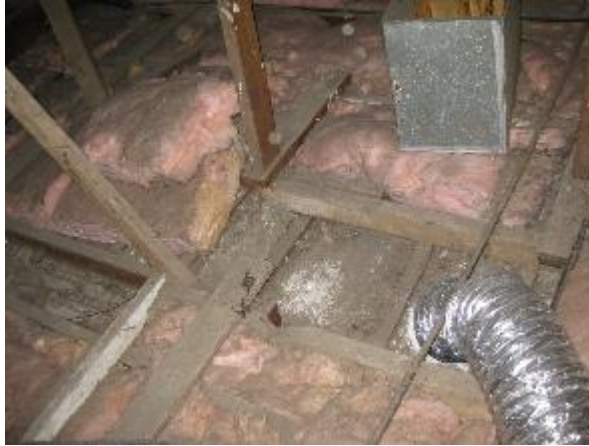
Roof insulation Insulation to part of roof space Minor Defect Type: F
Insulation is displaced or missing in significant parts of roof space. This would significantly reduce the overall performance of the insulation.

Insulation is displaced or missing in significant parts of roof space. This would significantly reduce the overall performance of the insulation.

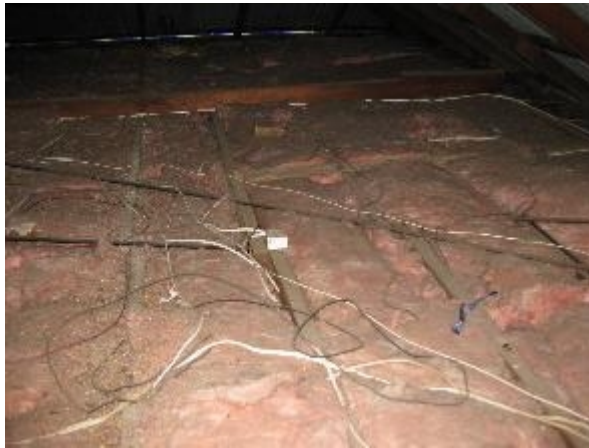
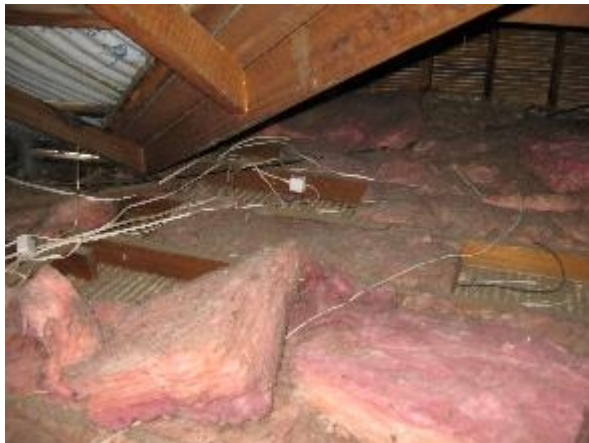
Roof wiring Old wiring in roof that should be removed & replaced Safety Hazard Type: D
There is old rubber insulated wiring present. This should not be present in the roof if the house has been rewired. Investigation by a licensed Electrician is needed.

Roof wiring Substandard wiring Safety Hazard Type: F
New wiring has not been installed as per Australian Standards. It has not been secured to the ceiling joists. Recommend rectification by a licensed Electrician.

There is old rubber insulated wiring present. This should not be present in the roof if the house has been rewired. Investigation by a licensed Electrician is needed.

New wiring has not been installed as per Australian Standards. It has not been secured to the ceiling joists. Recommend rectification by a licensed Electrician.
